Seaside 1 Firehouse

Town of Manchester-by-the-Sea ADA Transition Plan

February 2020

Institute for Human Centered Design

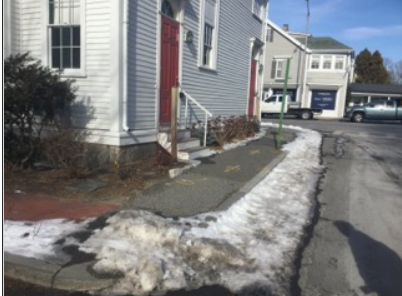
ID	Location	Floor	Room	Element	Type	Photo	Issues	Current Measure	Recommendations	Quantity	Price	Cost Estimation
Approach and Entrance												
Exterior Access Route												
1	Walkway by Parking	Ext		Exterior Access Route	Walkway

Route not maintained in operable working condition	-	Ensure the accessible route is maintained in operable working condition (remove snow).	1	Labor	\$0
2	Walkway to Museum Accessible Entrance	Ext		Exterior Access Route	Exterior

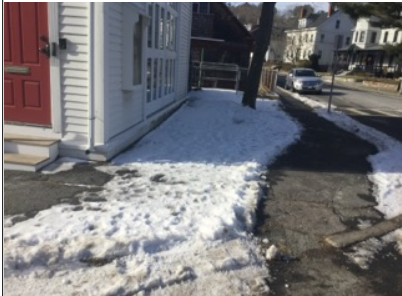
Route not maintained in operable working condition	-	Ensure the accessible route is maintained in operable working condition (remove snow).	1	Labor	\$0
Off-Street Parking Lot or Garage												
3	Parking	Ext.		Off-Street Parking Lot or Garage	N/A

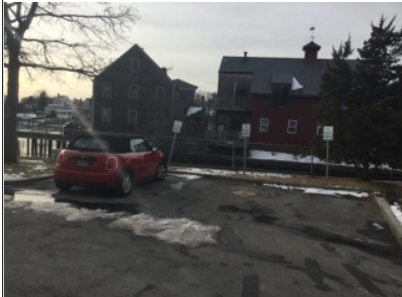
Total # of parking Total # of designated accessible parking spaces Vehicle space < 132" wide at van space Access aisle < 60" wide at car/van space Sign not provided Sign does not have the designation "Van Accessible"	4 - - -	Provide a van accessible parking space that is at least 132" wide min. with a marked access aisle that is at least 60" wide min. Provide a sign with the International Symbol of Accessibility (ISA). Add the designation "Van Accessible" to the sign located at the van accessible space, and mount the sign 60" min. and 96" max. above the ground.	1	1850	\$1850

- Renovate parking: \$1,850

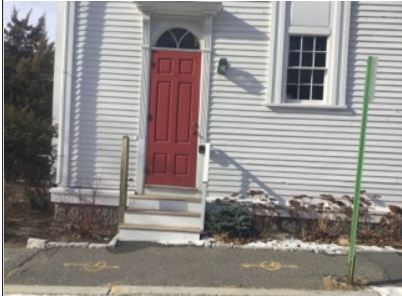
Entrance												
4	Entrance to Museum and Meeting Room	Ext		Entrance	Main Entrance

Entrance not on an accessible route Directional sign to accessible entrance not provided Hardware not operable with a closed fist	- -	Provide a directional sign indicating the location of the nearest accessible entrance. Provide hardware that can be operable with one hand and not require tight grasping, pinching, or twisting of the wrist.	1	830	\$830
Access to Goods and Services

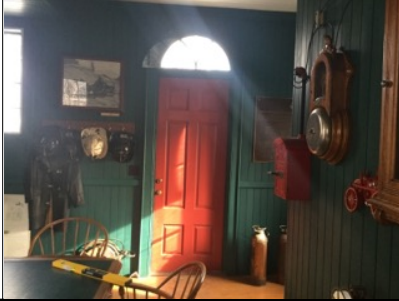
ID	Location	Floor	Room	Element	Type	Photo	Issues	Current Measure	Recommendations	Quantity	Price	Cost Estimation
Means of Egress												
5	Egress to Stairs	1		Means of Egress	N/A

Illuminated exit sign not provided Tactile exit sign not provided	- -	Ensure illuminated exit signs are provided at exits and exit doors. Ensure tactile exit signs with raised characters and braille are provided at exit doors. Mount signs between 48"- 60" above finished floor located on the latch side of the door.	1	432	\$432
6	Accessible Exit to Ramp	1		Means of Egress	N/A

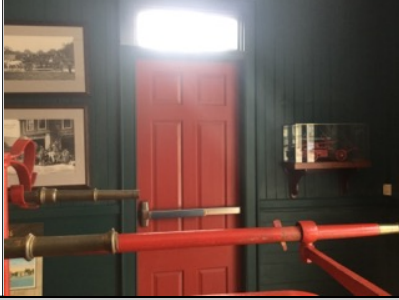
Illuminated exit sign not provided Tactile exit sign not provided Illuminated Int. Symbol of Acc. not provided (MAAB)	- -	Ensure illuminated exit signs are provided at exits and exit doors. Ensure tactile exit signs with raised characters and braille are provided at exit doors. Mount signs between 48"- 60" above finished floor located on the latch side of the door. Provide an illuminated International Symbol of Accessibility (ISA).	1	964	\$964

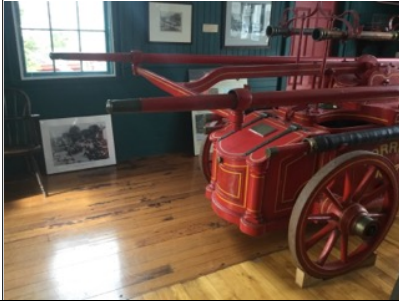
Interior Access Route												
7	Museum	1		Interior Access Route	N/A

Obstructed by protruding objects	19"	Provide a cane-detectable barrier.	1	306	\$306
Doors, Doorways, & Gates												
8	Accessible/ Rear Museum Entrance	Ext		Doors, Doorways, & Gates	Other

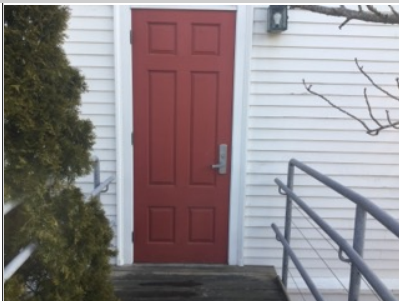
Maneuvering clearance(s) not provided	14"	Provide an automatic door opener.	1	3060	\$3060
9	Single-User Toilet Room in Museum and Meeting Space	1		Doors, Doorways, & Gates	Toilet Room

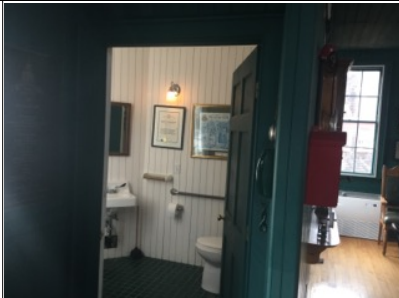
Hardware not operable with a closed fist	-	Provide hardware that can be operable with one hand and not require tight grasping, pinching, or twisting of the wrist.	1	484	\$484

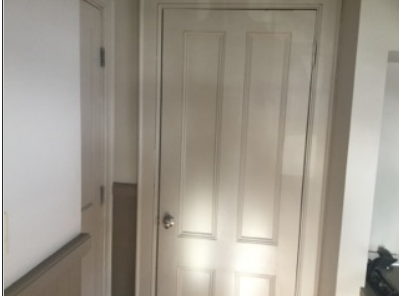
ID	Location	Floor	Room	Element	Type	Photo	Issues	Current Measure	Recommendations	Quantity	Price	Cost Estimation
10	Planning Office	2		Doors, Doorways, & Gates	Circulation

Hardware not operable with a closed fist	-	Provide hardware that can be operable with one hand and not require tight grasping, pinching, or twisting of the wrist.	1	484	\$484
11	Entrance to Conservation and Planning Offices	Ext		Doors, Doorways, & Gates	Other

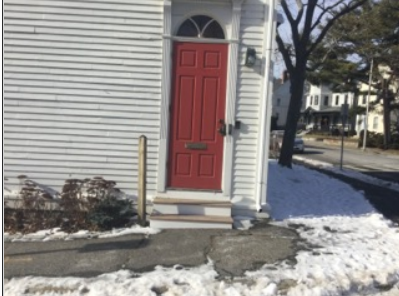
Hardware not operable with a closed fist	-	Provide hardware that can be operable with one hand and not require tight grasping, pinching, or twisting of the wrist.	1	484	\$484
Operable Parts												
12	By Ground Floor Exit from Conservation and Planning Offices	1		Operable Parts	Clothes Rod/Hooks

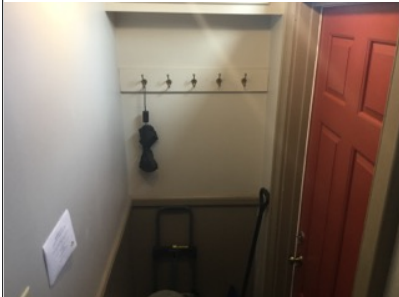
Side reach > 54"	72"	Relocate coat hooks so that they are between 15" - 48" above finished floor.	1	256	\$256
13	Single-User Toilet Room	1		Operable Parts	Clothes Rod/Hooks

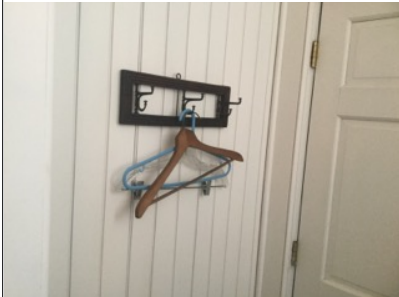
Side reach > 54"	62"	Relocate coat hooks so that they are between 15" - 48" above finished floor.	1	256	\$256

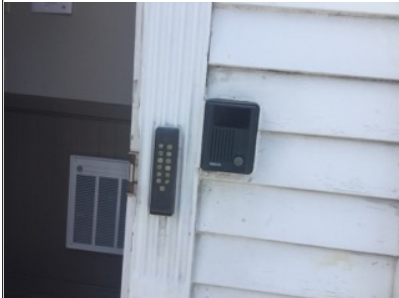
14	Entrance to Conservation and Planning Offices	Ext		Operable Parts	Equipment

Side reach > 54"	61"	Relocate intercom and doorbell so that controls are between 15" - 48" above finished floor.	1	884	\$884

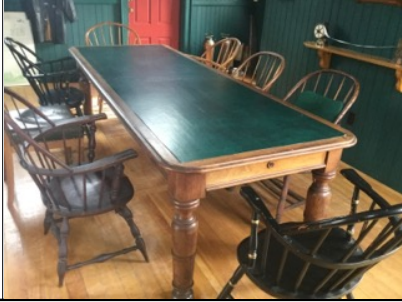
ID	Location	Floor	Room	Element	Type	Photo	Issues	Current Measure	Recommendations	Quantity	Price	Cost Estimation
Dining or Work Surfaces												
15	Museum Meeting Room	1		Dining or Work Surfaces	Work Surface

Knee or toe clearance not provided	24'	Provide at least 1 work surface with 27" min. knee and toe clearance.	1	700	\$700
Toilet & Bathing Rooms												
Overall Access												
16	Single-User Toilet Room	1		Overall Access	Toilet Room

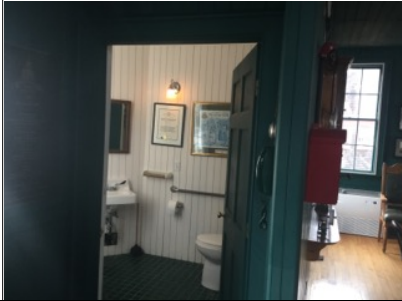
International Symbol of Acc. not provided Hardware not operable with a closed fist	-	Provide hardware that can be operable with one hand and not require tight grasping, pinching, or twisting of the wrist. Provide a sign with the International Symbol of Accessibility.	1	716	\$716
Lavatory												
17	Single-User Toilet Room	1		Lavatory	N/A

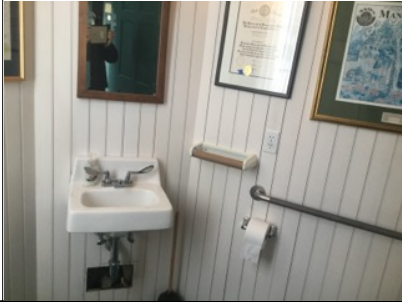
Plumbing underneath is exposed Mirror above lavatory w/reflective surface > 40"	- 48"	Insulate or otherwise configure pipes to prevent contact, for at least one lavatory. Lower mirror so that the bottom surface is at 40" max. above finished floor.	1	352	\$348

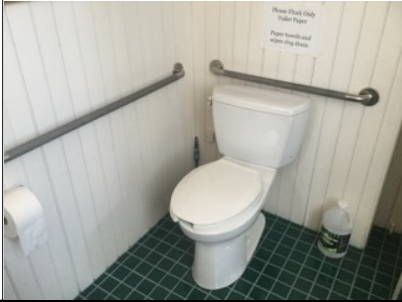
Flush control not on open side Toilet paper dispenser is not compliant	- 16"	Relocate the flush control to the open side. Relocate toilet paper so that it is 15" min. high, located under the grab bar, and between 7" and 9" from the front of the toilet.	1	1080	\$1080
Additional Access

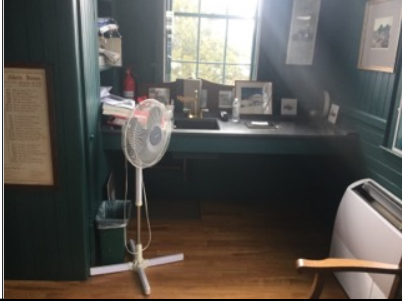
ID	Location	Floor	Room	Element	Type	Photo	Issues	Current Measure	Recommendations	Quantity	Price	Cost Estimation
Sink												
19	Museum	1		Sink	N/A

Exposed plumbing underneath sink	-	Insulate or otherwise configure pipes at sink.	1	92	\$92
Best Practice												
Stairs												
20	Entrance to Conservation and Planning Offices	Ext		Stairs	N/A

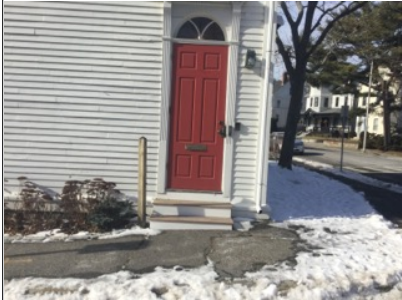
Recommend providing handrails with extensions at bottom landing on both sides of stair.	1	-	\$0
Stairway Railing												
21	Stairway to Offices	2		Stairway Railing	N/A

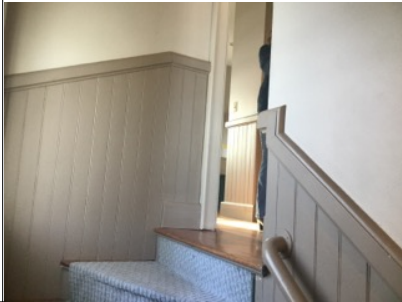
Recommend providing vertical handrail above existing railing at top of stairs.	1	-	\$0
Stairways												
22	Entrance to Museum and Meeting Space	Ext		Stairways	N/A

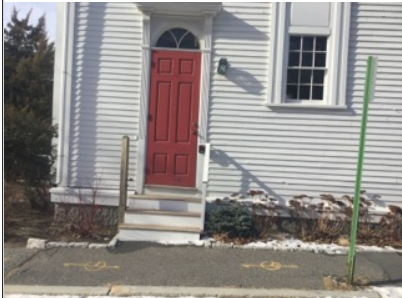
Recommend providing handrails with extensions at bottom landing on both sides of stair.	1	-	\$0

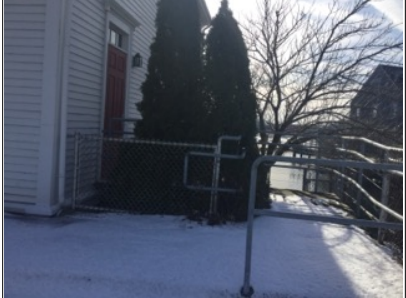
ID	Location	Floor	Room	Element	Type	Photo	Issues	Current Measure	Recommendations	Quantity	Price	Cost Estimation
Walkway												
23	Elevated Walkway to Museum and Meeting Space Accessible Entrance	Ext		Walkway	N/A

Recommend providing edge protection along the elevated portion of walkway along the north side of the building that leads to the museum and meeting space accessible entrance.	1	-	\$0
