Public Library

Town of Manchester-by-the-Sea ADA Transition Plan

February 2020

**Town of Manchester-by-the-Sea
Public Library**

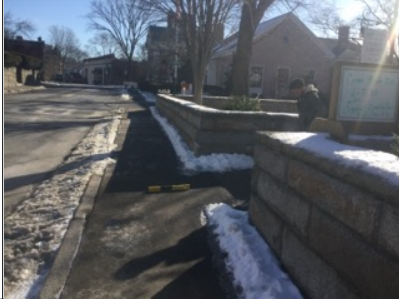
Cross slope > 1:50 (2.00%)	4.5%	Reduce cross slope to be no steeper than 1:50 (2.00%). (Cost for 3'x3' of asphalt to correct slope.)	1	90	\$90
2	Path to Children's Area Entrance	Ext.		Exterior Access Route	Exterior

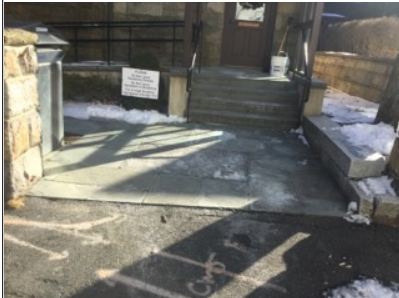
Level changes > 1/4"	1"	Alter change in level to be 1/4" high max. (Cost for a 3'x3' concrete patch.)	1	144	\$144
3	By Ramp	Ext.		Exterior Access Route	Exterior

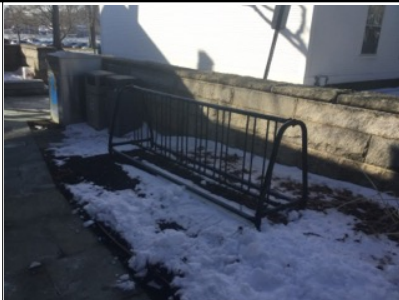
Accessible route not provided	-	Ensure an accessible route is provided to the bike rack. (Cost for a 3'x3' concrete patch.)	1	144	\$144
4	Front of Library Near Union Street	Ext.		Exterior Access Route	Walkway

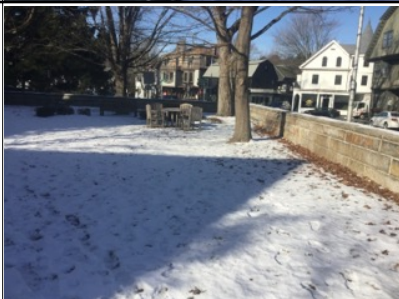
Accessible route not provided	-	Ensure an accessible route is provided to the table and chairs in front of library along Union Street. (Cost based on a 48" wide 30' long stone dust walkway to table area.)	1	960	\$960

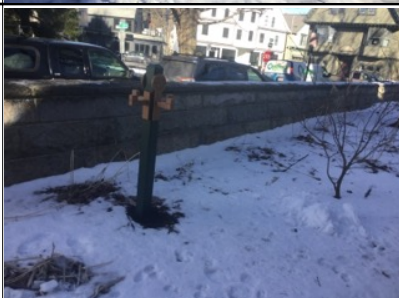
5	Near Church Street Ramp	Ext.		Exterior Access Route	Walkway

Accessible route not provided	-	Ensure an accessible route is provided to the pet tie-up area. (Cost based on a 48" wide x 6' long stone dust path.)	1	192	\$192
Access to Goods and Services

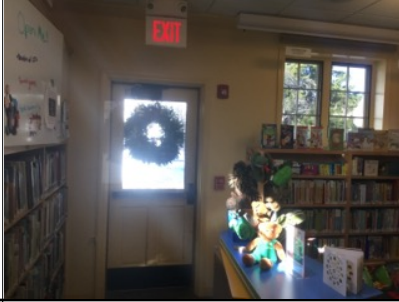
Tactile exit sign not provided Illuminated Int. Symbol of Acc. not provided	-	Ensure tactile exit signs with raised characters and braille are provided at exit doors. Mount signs between 48"- 60" above finished floor located on the latch side of the door. Provide a sign with an illuminated International Symbol of Accessibility (ISA).	1	432	\$432
7	Central/ Union Street Exit	1		Means of Egress	N/A

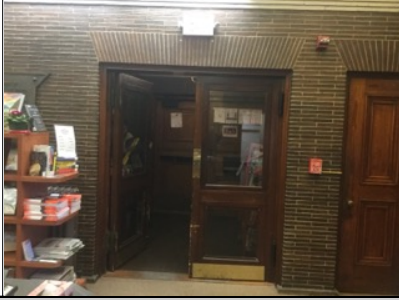
Tactile exit sign not provided Illuminated Int. Symbol of Acc. not provided	-	Ensure tactile exit signs with raised characters and braille are provided at exit doors. Mount signs between 48"- 60" above finished floor located on the latch side of the door. Provide a sign with an illuminated International Symbol of Accessibility (ISA).	1	432	\$432

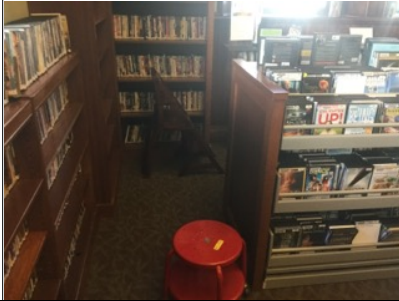
Interior Access Route												
8	Main Room	1		Interior Access Route	N/A

Route < 36" wide	30"	Ensure that a clear width of 36" min. is maintained at the accessible route (shift location of large stand).	1	Labor	\$0
9	Path to Stairs to Mezzanine	1		Interior Access Route	N/A

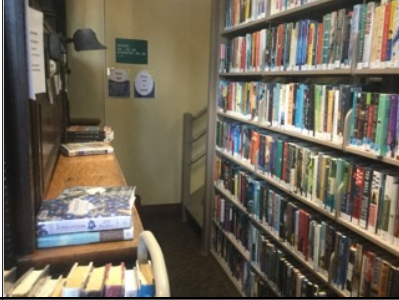
Route < 36" wide	33"	Ensure that a clear width of 36" min. is maintained at the accessible route (relocate items to create a 36" min. wide path to stairs).	1	Labor	\$0
10	Friends of Library Volunteer Area	1		Interior Access Route	N/A

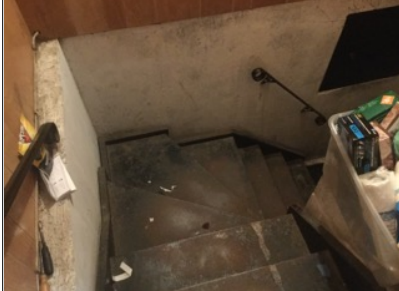
Accessible route not provided	-	Providing an accessible route to the basement Friends of Library area may be technically infeasible. To provide program access, recommend relocating the Friends of the Library area to an accessible location as needed.	1	Labor	\$0

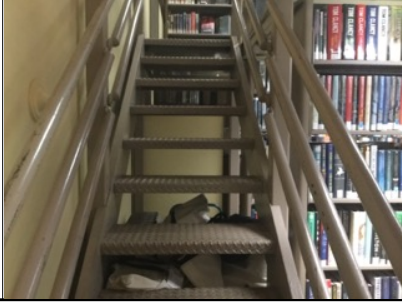
ID	Location	Floor	Room	Element	Type	Photo	Issues	Current Measure	Recommendations	Quantity	Price	Cost Estimation
11	Stairs to Mezzanine	1		Interior Access Route	N/A

Accessible route not provided	- -	Provide an accessible route to the mezzanine teen area. (Cost based on a new interior lift.)	1	21660	\$21660
Doors, Doorways, & Gates												
12	Staff Office	1		Doors, Doorways, & Gates	Office

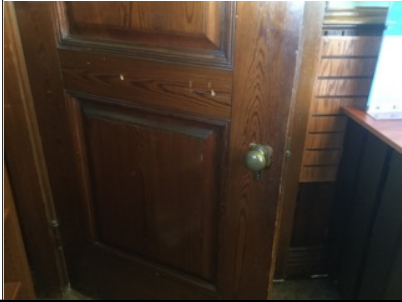
Hardware not operable with a closed fist	-	Provide hardware that can be operable with one hand and not require tight grasping, pinching, or twisting of the wrist.	1	484	\$484
13	Single-User Toilet Room	1		Doors, Doorways, & Gates	Toilet Room

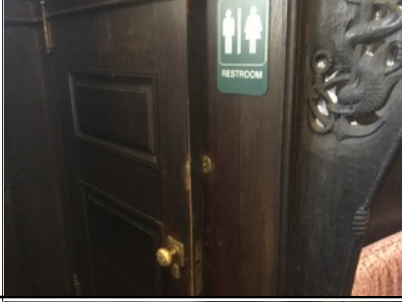
Hardware not operable with a closed fist	-	Provide hardware that can be operable with one hand and not require tight grasping, pinching, or twisting of the wrist.	1	484	\$484
14	Friends of Library Volunteer Area	b		Doors, Doorways, & Gates	Other

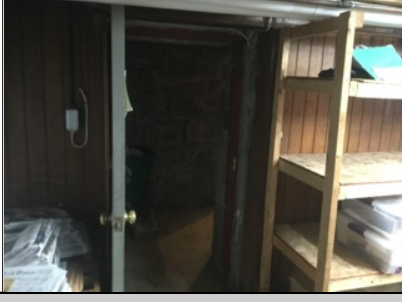
Hardware not operable with a closed fist	-	Provide hardware that can be operable with one hand and not require tight grasping, pinching, or twisting of the wrist.	1	484	\$484

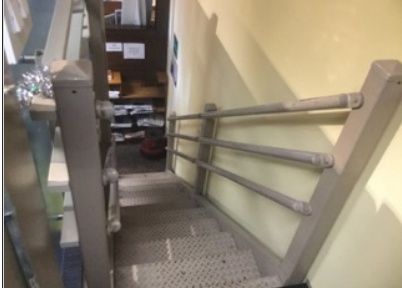
Stairways												
15	Mezzanine	M		Stairways	Interior

Handrails do not extend 12" from stairs	-	Top: Ensure handrails extend horizontally above the landing for 12" min. beginning above the first riser nosing. Bottom: Ensure handrails extend to one tread depth beyond the last riser. (Cost based on welding extensions on existing railing at top and bottom of stairs.)	4	142	\$568

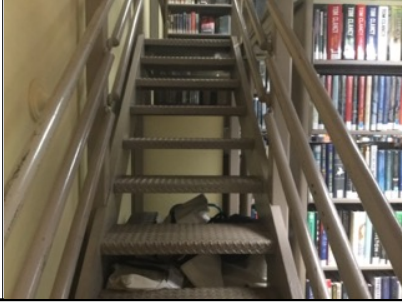
ID	Location	Floor	Room	Element	Type	Photo	Issues	Current Measure	Recommendations	Quantity	Price	Cost Estimation
16	Stairs to Mezzanine	1		Stairways	Interior

Stair has open risers	-	Ensure stairs have closed risers. (Cost based on filling in 16 metal risers.)	1	2624	\$2624
Service Counter												
17	Circulation Desk	1		Service Counter	N/A

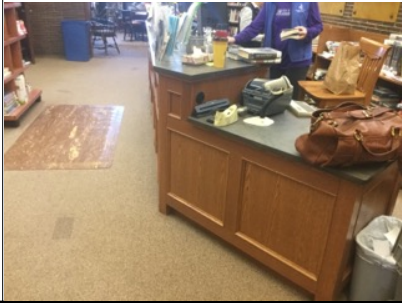
Keep accessible service counter clear of stored and displayed items.	1	Labor	\$0
Benches												
18	Front of Library Near Union Street	Ext.		Benches	N/A

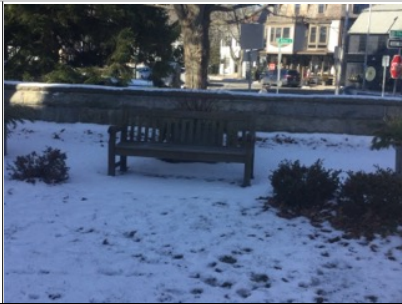
No accessible route to 20% of benches 20% of benches have clear space < 36" x 48"	- -	Provide an accessible route to bench in this area. Ensure bench has a stable, firm and slip resistant clear floor space of 36" wide min. by 48" deep min. adjacent to the bench at one end. (Cost based on a 48" wide 15' long stone dust walkway to table area.)	1	480	\$480
Toilet & Bathing Rooms

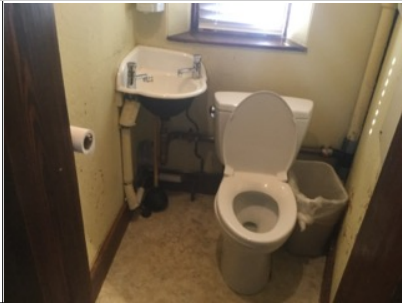
Overall Access												
19	Single-User Toilet Room	1		Overall Access	Toilet Room

Turning space not provided	-	Add an accessible single-user toilet room.	1	24604	\$24604
Best Practice

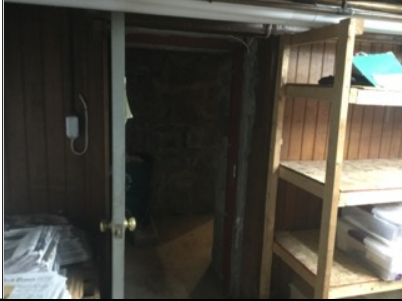
ID	Location	Floor	Room	Element	Type	Photo	Issues	Current Measure	Recommendations	Quantity	Price	Cost Estimation
Ceiling Height												
20	Friends of Library Volunteer Area	B		Ceiling Height	N/A

Recommend providing a sign at the entrance to the Friends of the Library area that reads, 'Low Ceiling' as the ceiling is just 72" high.	1	-	\$0
Entrance Door												
21	Door at Ramp to Children's Area	Ext.		Entrance Door	N/A

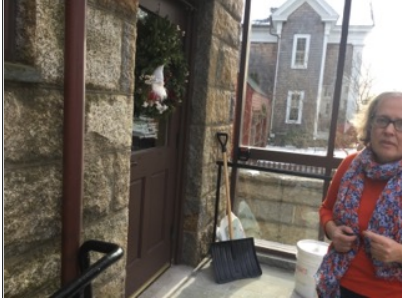
Recommend providing an automatic door opener. (The opening force for the door is at the heavy end of the allowable range, but multiple library users have said the door is too heavy for them to open when carrying books and in similar situations.)	1	-	\$0
On-Street Parking												
22	Church Street Parking	Ext.		On-Street Parking	N/A

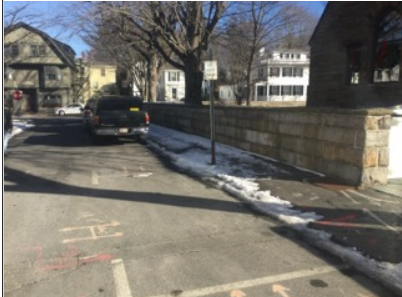
Recommend designating the street parking space closest to the route to the ramp by the children's area entrance as accessible by installing a sign with the International Symbol of Accessibility (ISA) with the base of the sign 60" min. and the top of the sign 96" max. above the ground.	1	-	\$0
