BOARD OF HEALTH

NOTIFICATION TO OWNER

Property Address: **38 MASCONOMO STREET, MANCHESTER-BY-THE-SEA**

Title 5 Official Inspection Form

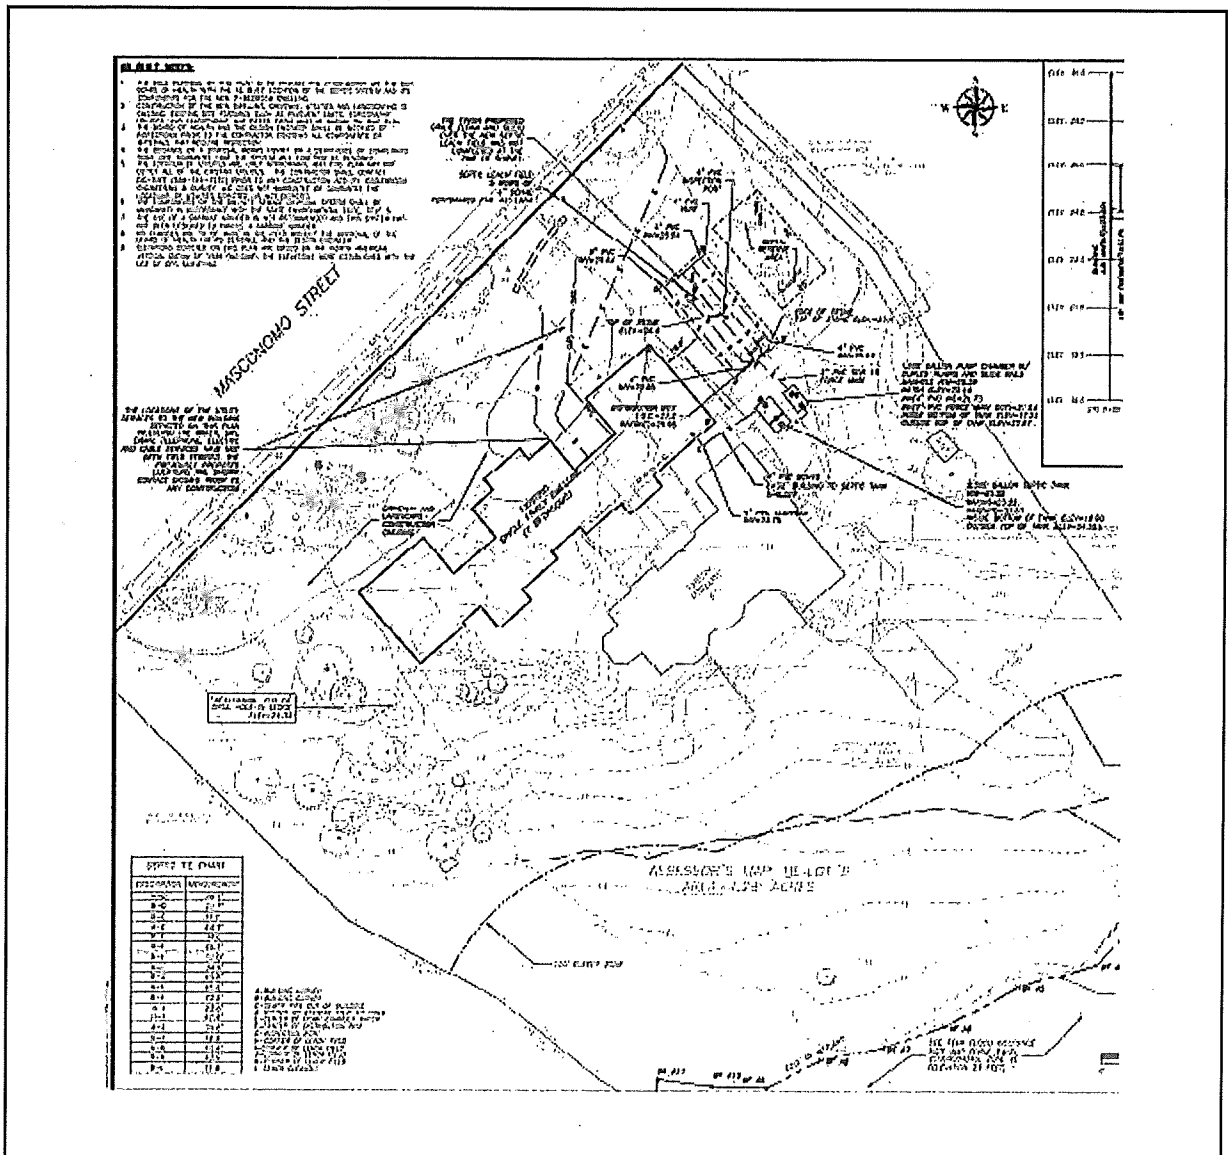
Provide a view of the sewage disposal system, including ties to at least two permanent reference landmarks or benchmarks. Locate all wells within 100 feet. Locate where public water supply enters the building. Check one of the boxes below:
