The Title 5 Inspection Report dated: 11/7/2023  
Amended Report Page 8 and Page 14 received on 1/23/2024

# Title 5 Official Inspection Form

Subsurface Sewage Disposal System Form - Not for Voluntary Assessments

15 Old Neck Road

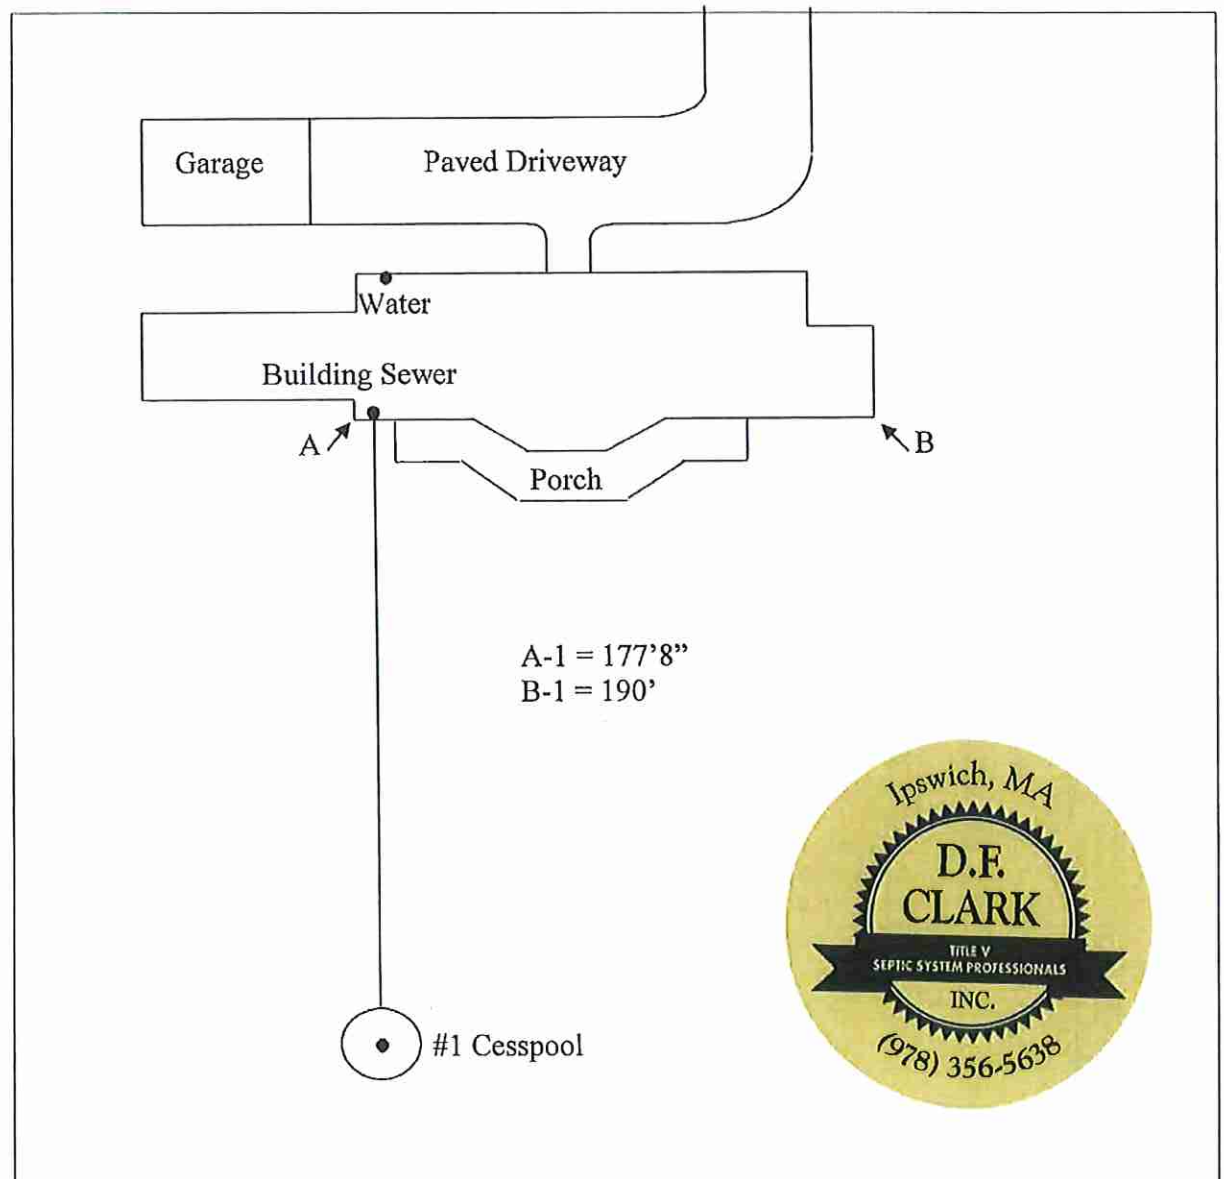
Provide a view of the sewage disposal system, including ties to at least two permanent reference landmarks or benchmarks. Locate all wells within 100 feet. Locate where public water supply enters the building. Check one of the boxes below:
